**REPORT NUMBER GSDR 805A**  
**NIGHT VISION SIGHT, INFRARED**  
**AN/TAS-3**  
**(U)**

FINAL REPORT

Contract No. DAAK02-72-C-0156

GOVERNMENT SYSTEMS DIVISION  
PHILIPS AUDIO VIDEO SYSTEMS CORP.  
91 MCKEE DRIVE, MAHWAH, N. J. 07430  
TEL: 201-529-3800 TWX: 710-988-5348  
A NORTH AMERICAN PHILIPS COMPANY

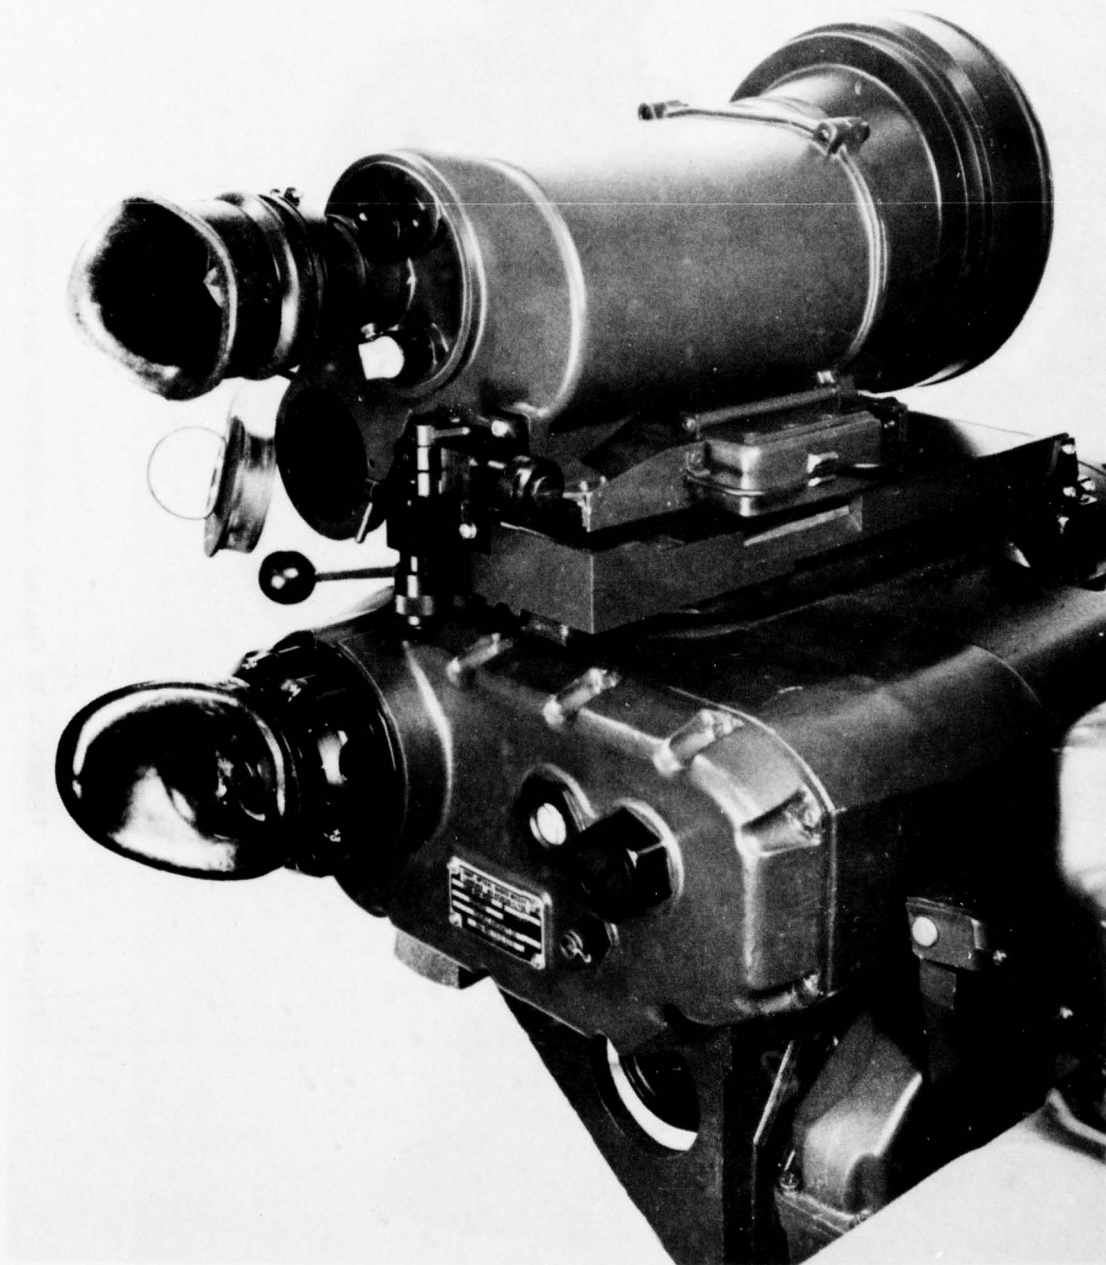
Figure 9-7. ER/NVS - J-T Cooled - TOW Configuration

TOW Configuration - A dedicated TOW configuration of the NVS is illustrated in Figures 9-6 and 9-7. This JT cooled unit includes an integral bore-sighting mechanism which attaches to the TOW weapon and incorporates a 7.2" focal length lens. The entire scanner assembly of this unit is identical to the AN/TAS-3. In a TE cooled unit, the outer housing will be substantially simplified by elimination of the tube portion of the housing required for the gas bottle and valve.

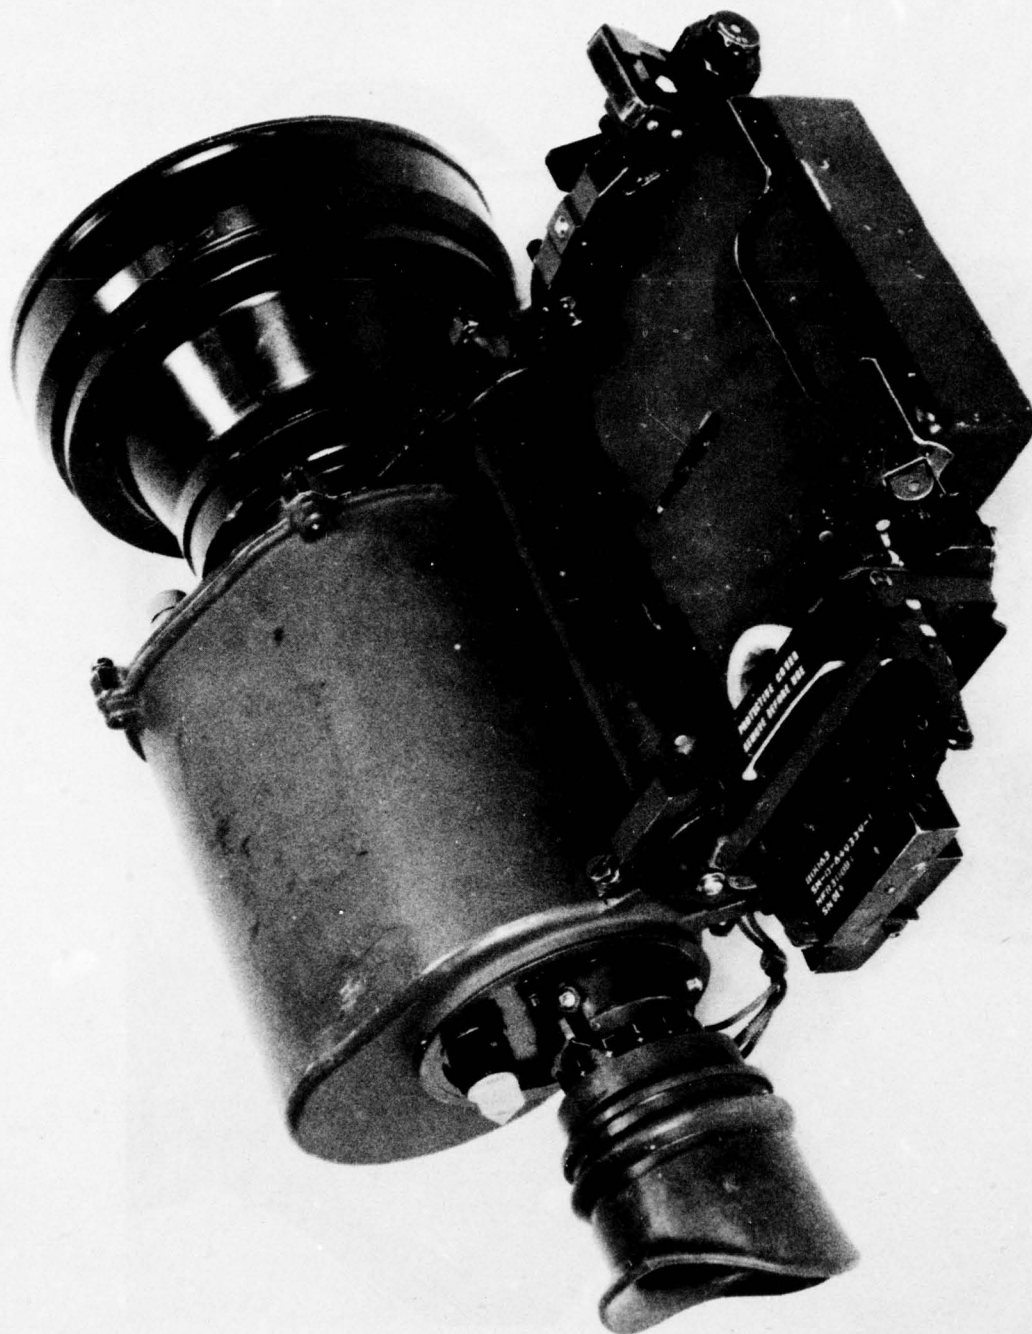
Figure 9-8. TE/NVS - TE Cooled - DRAGON/TOW Configuration

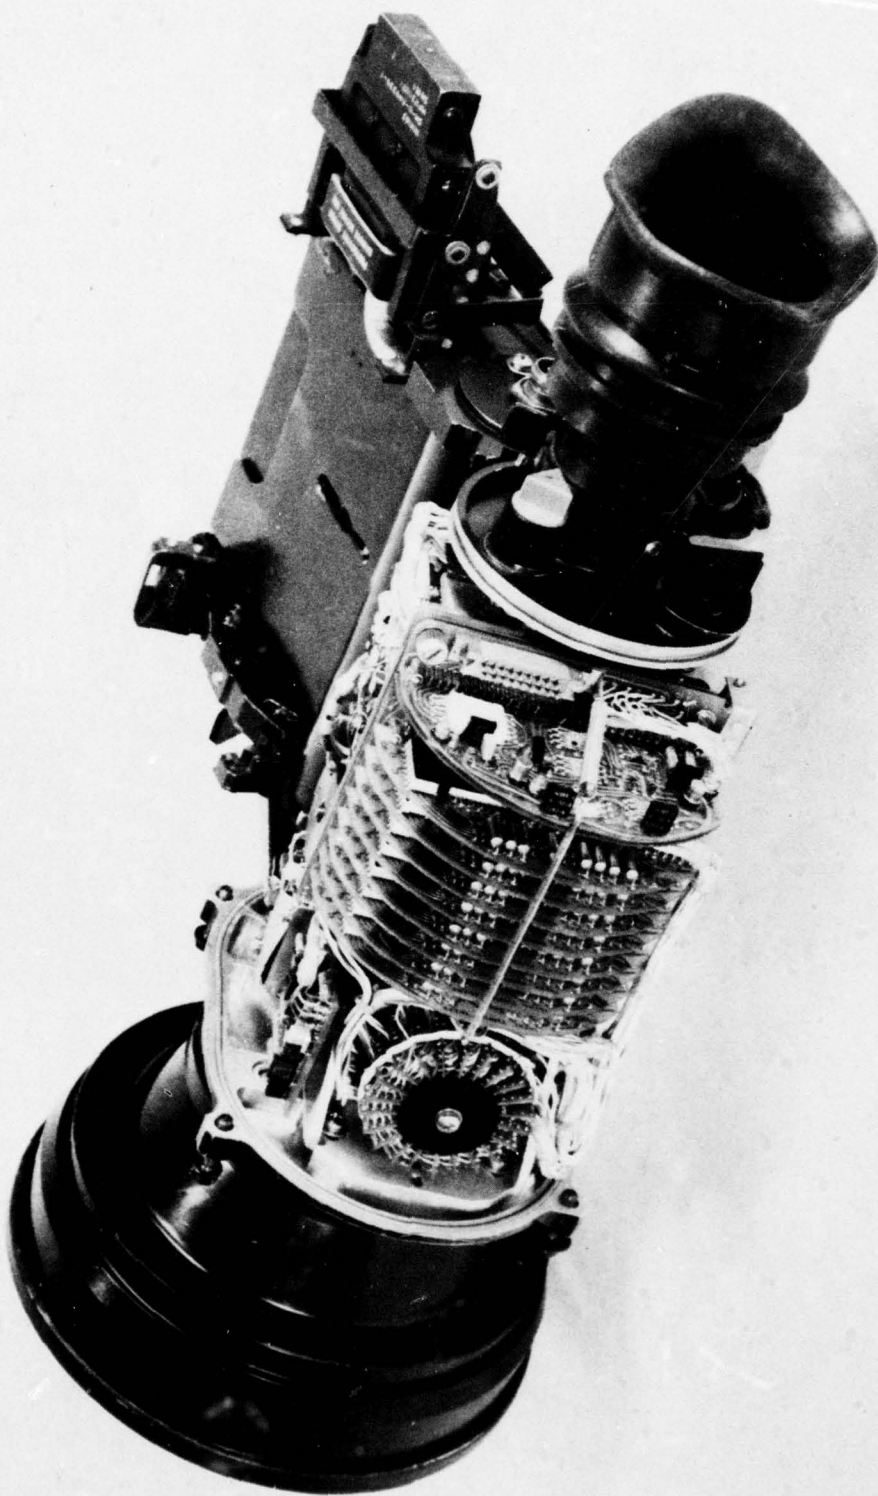
Figure 9-9. TE/NVS - TE Cooled - DRAGON/TOW Configuration

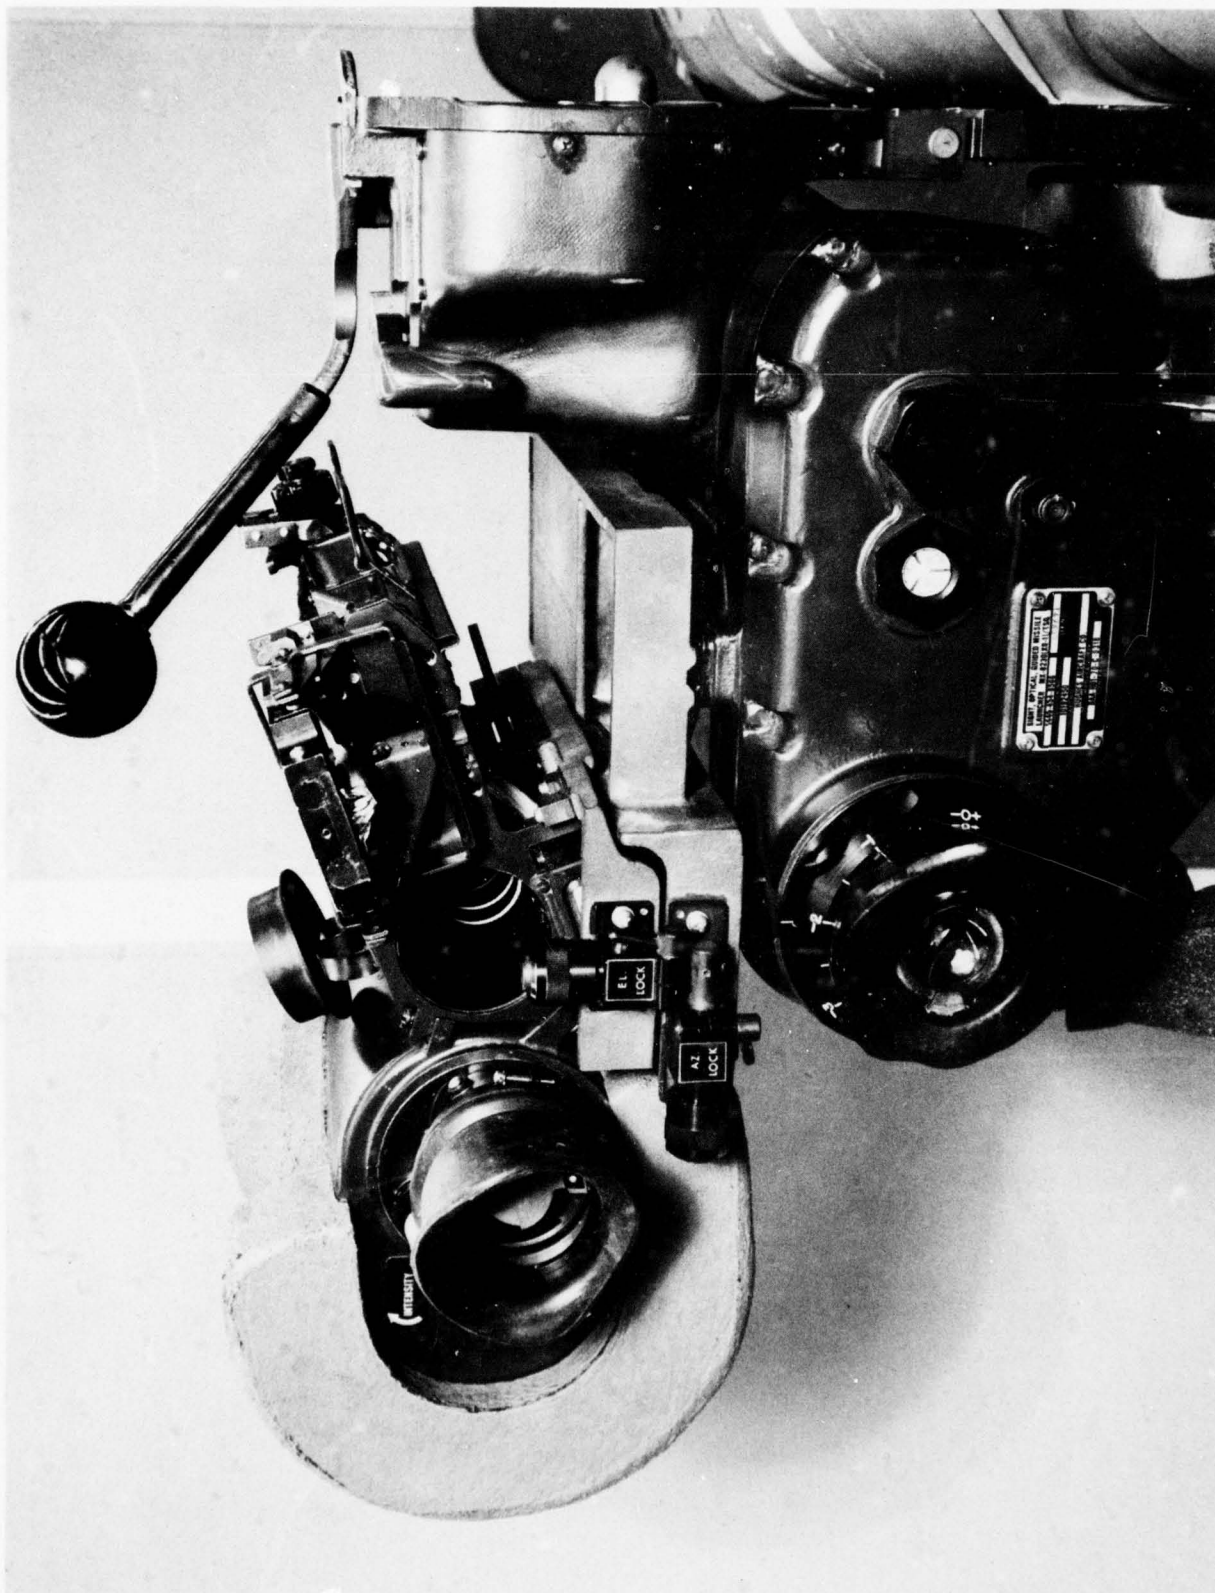
Figure 9-10. AN/TAS-3 with TOW Bracket

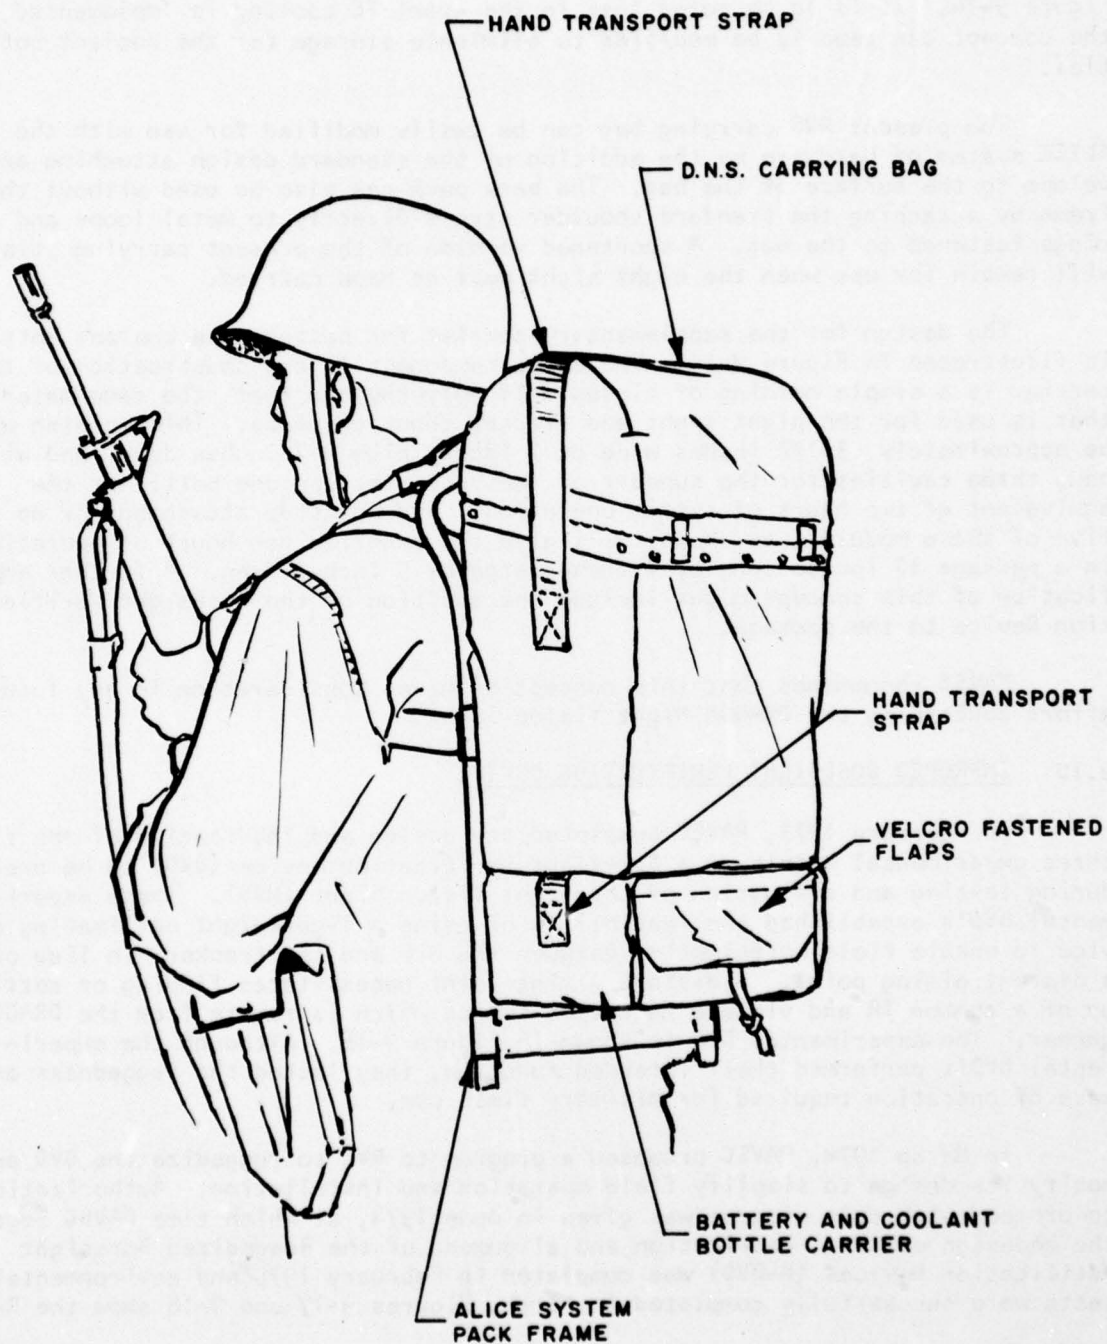
TP2453

Figure 9-14. "ALICE" Carrying Bag

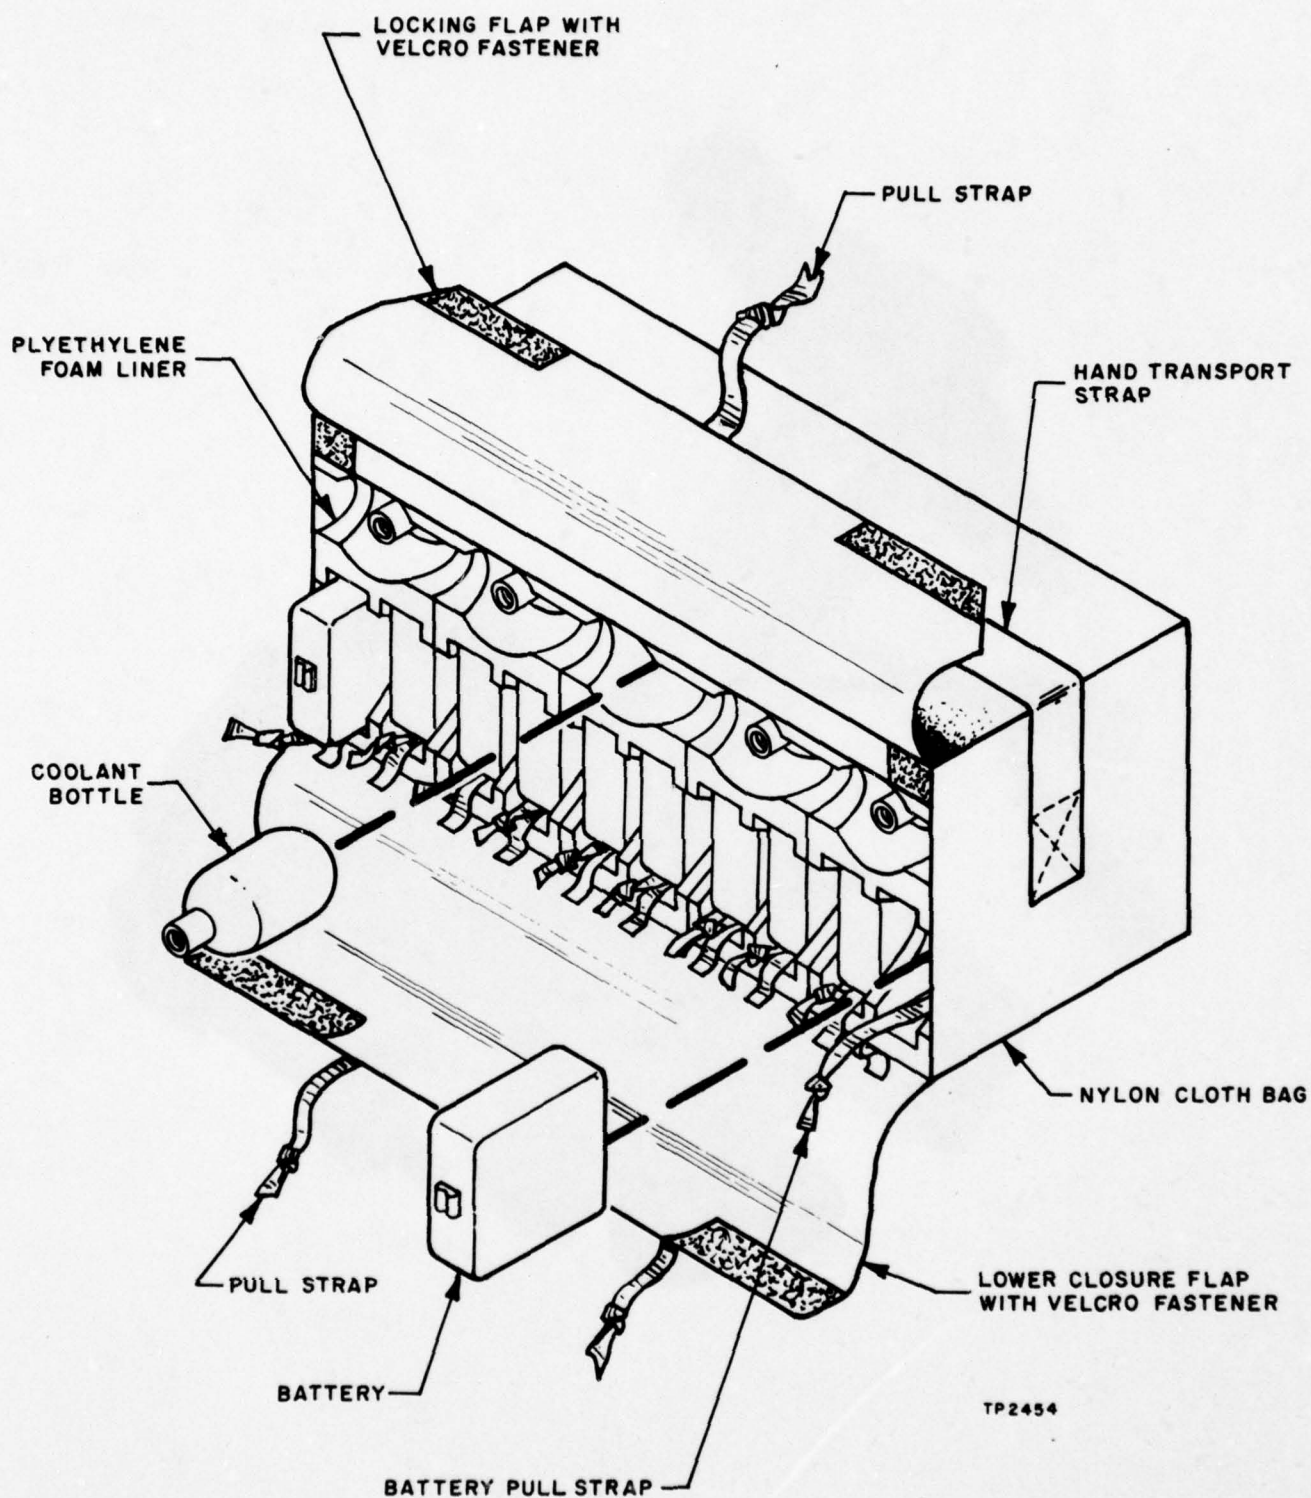
Figure 9-15. Internal View - "ALICE" Carrying Bag

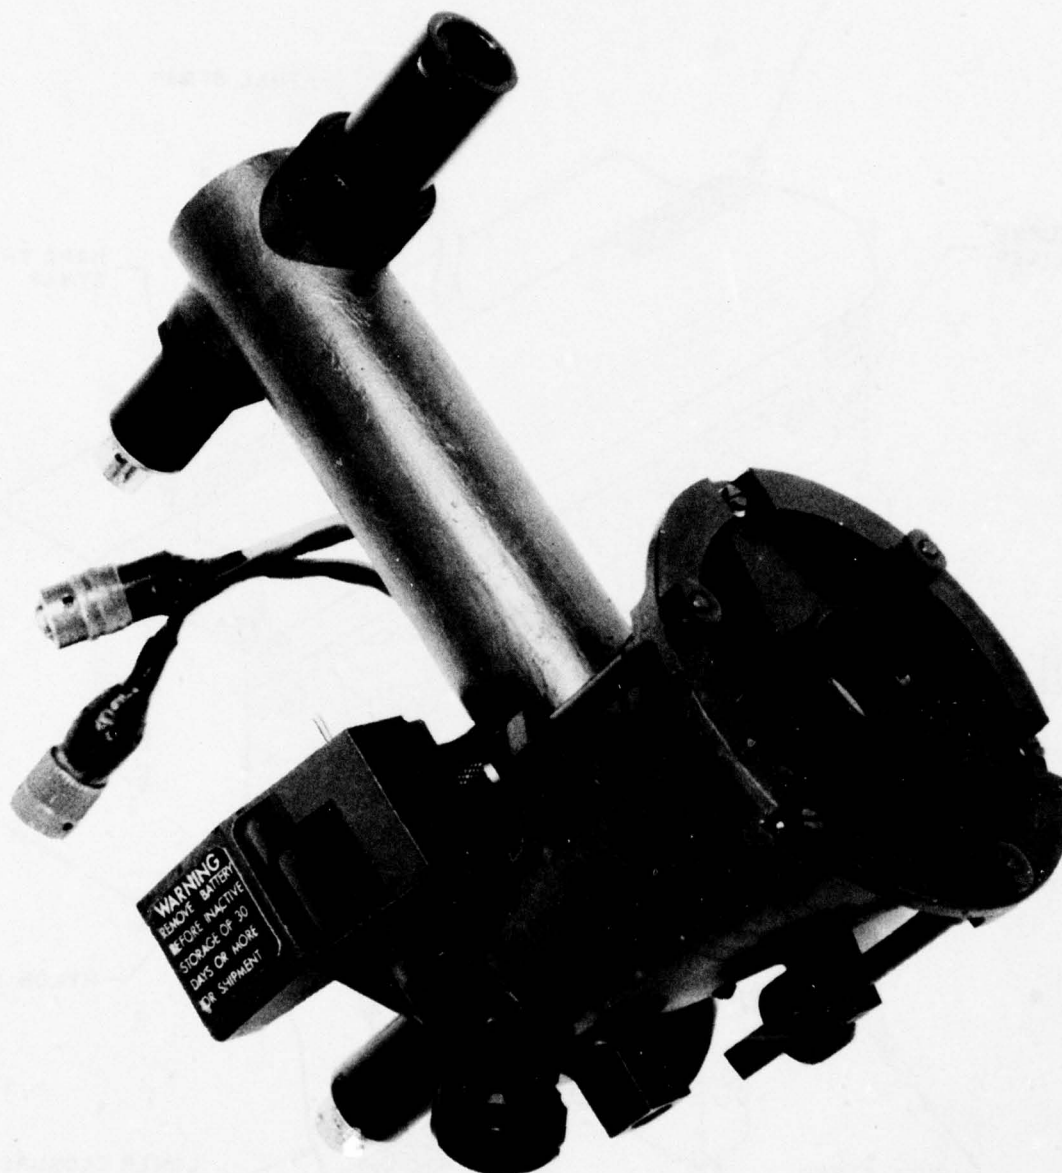
Figure 9-16. Boresight Verification Device - Experimental Model

In February 1973, PAVSC completed the design and fabrication of the first three experimental models of a Boresight Verification Device (BVD) to be used during testing and evaluation of the Night Vision Sight (NVS). These experimental BVD's established the feasibility of using a lightweight collimating device to enable field boresighting between the NVS and the tracker, in lieu of a distant aiming point. A distant aiming point necessitates finding or setting up of a common IR and visible radiation source which is remote from the DRAGON gunner. The experimental BVD is shown in Figure 9-16. Although the experimental BVD's performed their intended function, they lacked the ruggedness and ease of operation required for military field use.

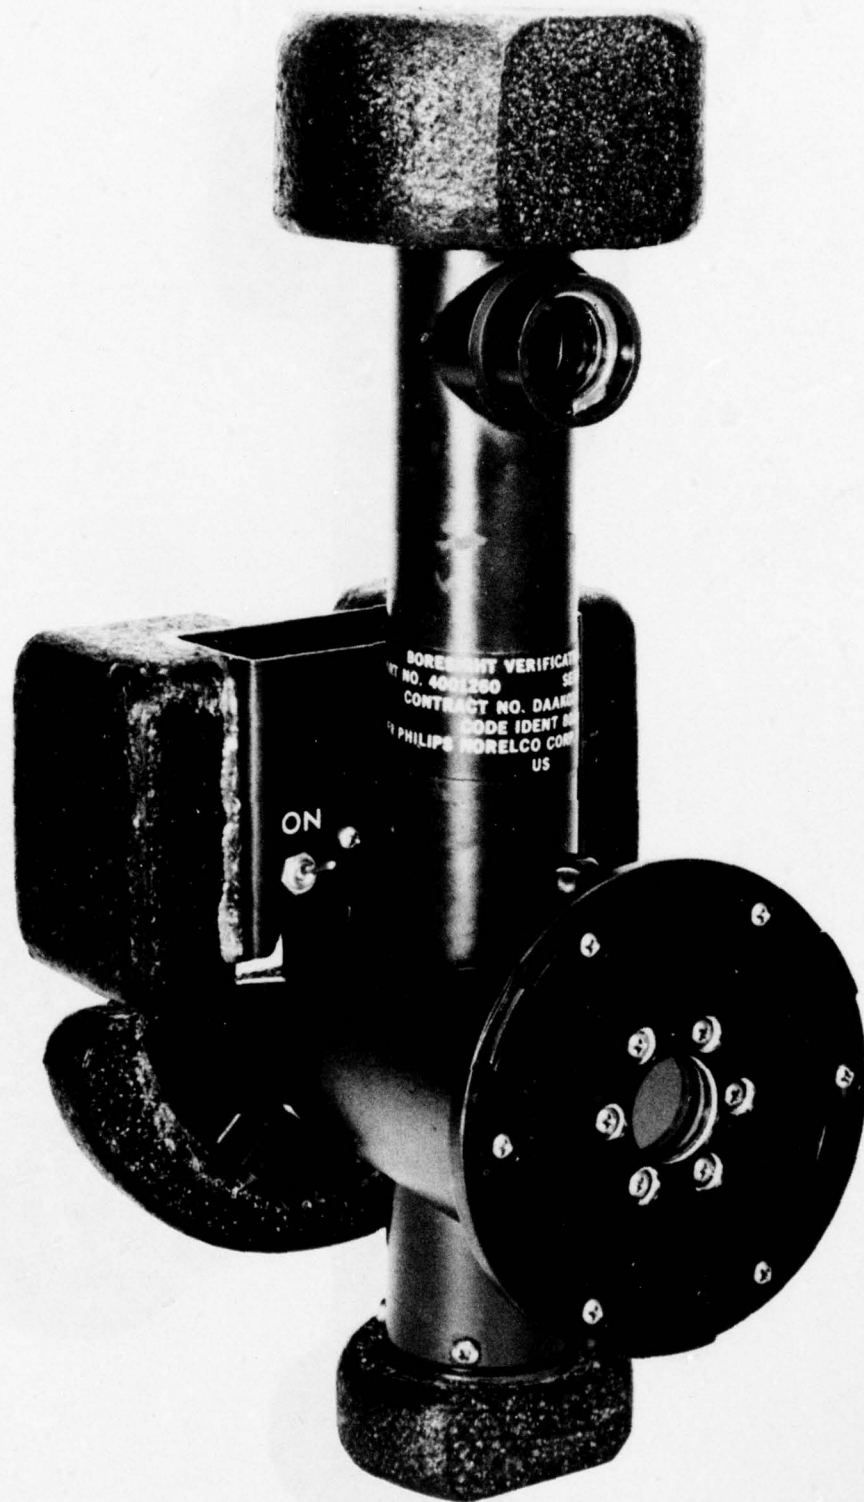
Figure 9-17. Boresight Verification Device - Ruggedized Model 1

In March 1974, PAVSC proposed a program to NVL to ruggedize the BVD and modify its design to simplify field operation and installation. Authorization to proceed with this program was given in June 1974, at which time PAVSC began the redesign effort. Fabrication and alignment of the Ruggedized Boresight Verification Devices (R-BVD) was completed in February 1975 and environmental tests were successfully completed in March. Figures 9-17 and 9-18 show the R-BVD.

All of the known shortcomings of the experimental models were corrected in the R-BVD. Improvements included:

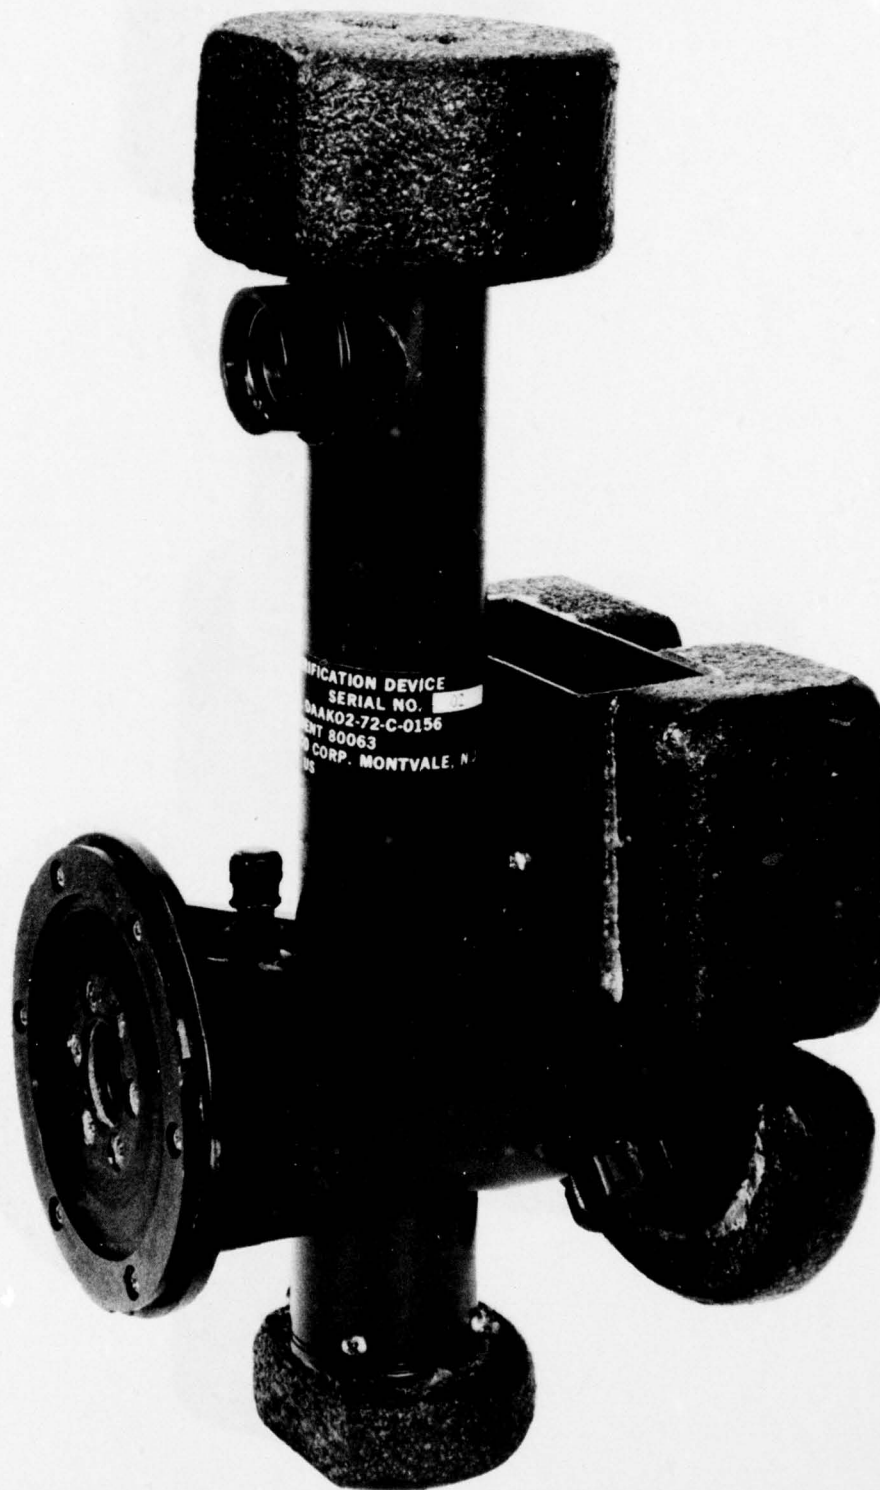
Figure 9-18. Boresight Verification Device - Ruggedized Model

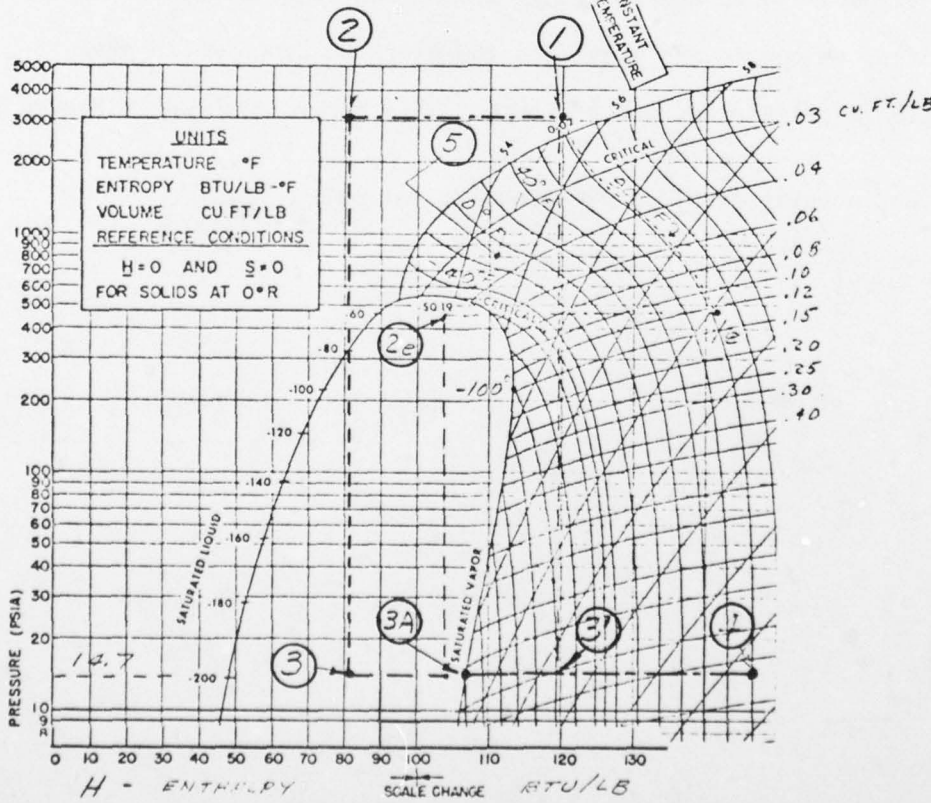
CRYOSTAT - DETECTOR SCHEMATIC

1. Gas, at temperature  $80^{\circ}$  F, and 3000 psi,  $\textcircled{1}$ , flows through the heat exchanger, at constant pressure, transfers heat to the outgoing gas and is cooled to state point  $\textcircled{2}$ . Expansion to atmospheric pressure through the orifice (throttling process) results in the gas/liquid mixture being at state point  $\textcircled{3}$ . Heat from the detector is then absorbed by the liquid, converting the liquid to vapor, and cools the detector in the process;  $\textcircled{3A}$

The cold vapor then flows out the heat exchanger, absorbing heat from the incoming gas. For a heat exchanger with 100% efficiency, the gas exit temperature is equal to the gas entrance temperature, state point 4. For the process just described the following enthalpy equations can be written:

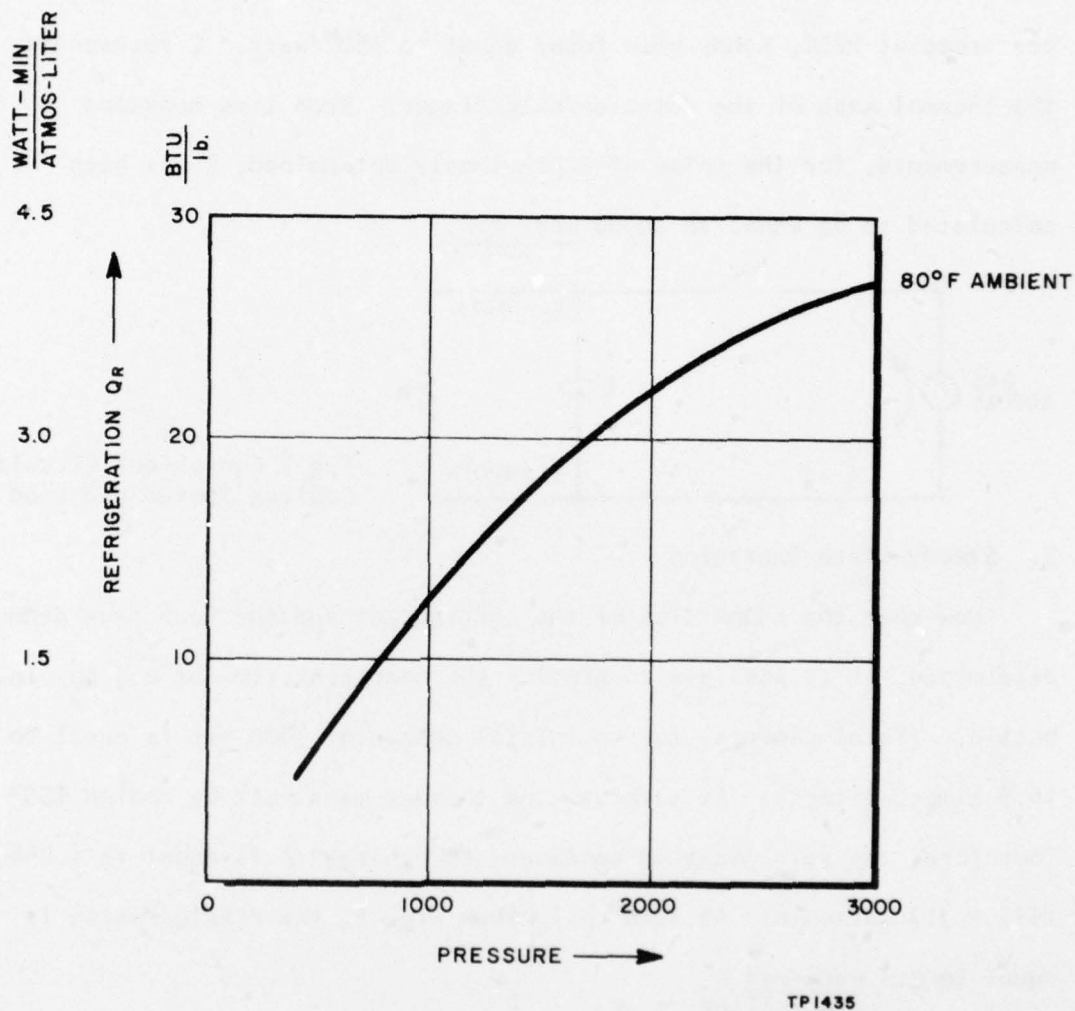
Fig. 2 REFRIGERATION AS A FUNCTION OF PRESSURE FOR FREON 14

For example, for an initial gas pressure of 3000 psi, 80° F, from the graph,  $Q_R$  is equal to 27 BTU/#. Other values can be obtained for other gas pressures. A continuous curve can therefore be drawn which gives refrigeration available vs. gas pressure. This curve is shown in Figure 2.

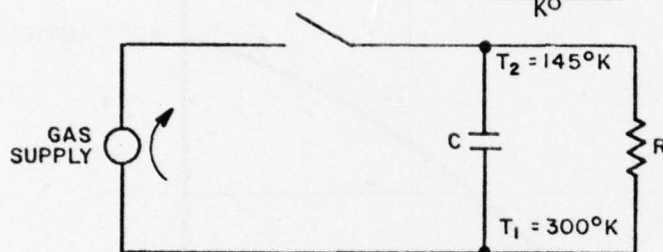
R is the equivalent thermal load; it represents all the possible heat leaks between the detector/cold finger and ambient. From tests performed at PBEC, R has been found equal to  $390^{\circ}/\text{watt}$ . C represents the thermal mass of the detector/cold finger. From time constant measurements, for the value of R previously determined, C has been calculated to be equal to  $.0486 \frac{\text{watt-min.}}{\text{K}^{\circ}}$ .

Fig 3 Equivalent Circuit of Cooling System and Load

The derived equivalent circuit of the cooling system is shown in Figure 3.
